# EURO CONSTRUCTION, INC.

19 Cardinal Rd., Suite A-1, Hilton Head Isl., SC 29926-3776

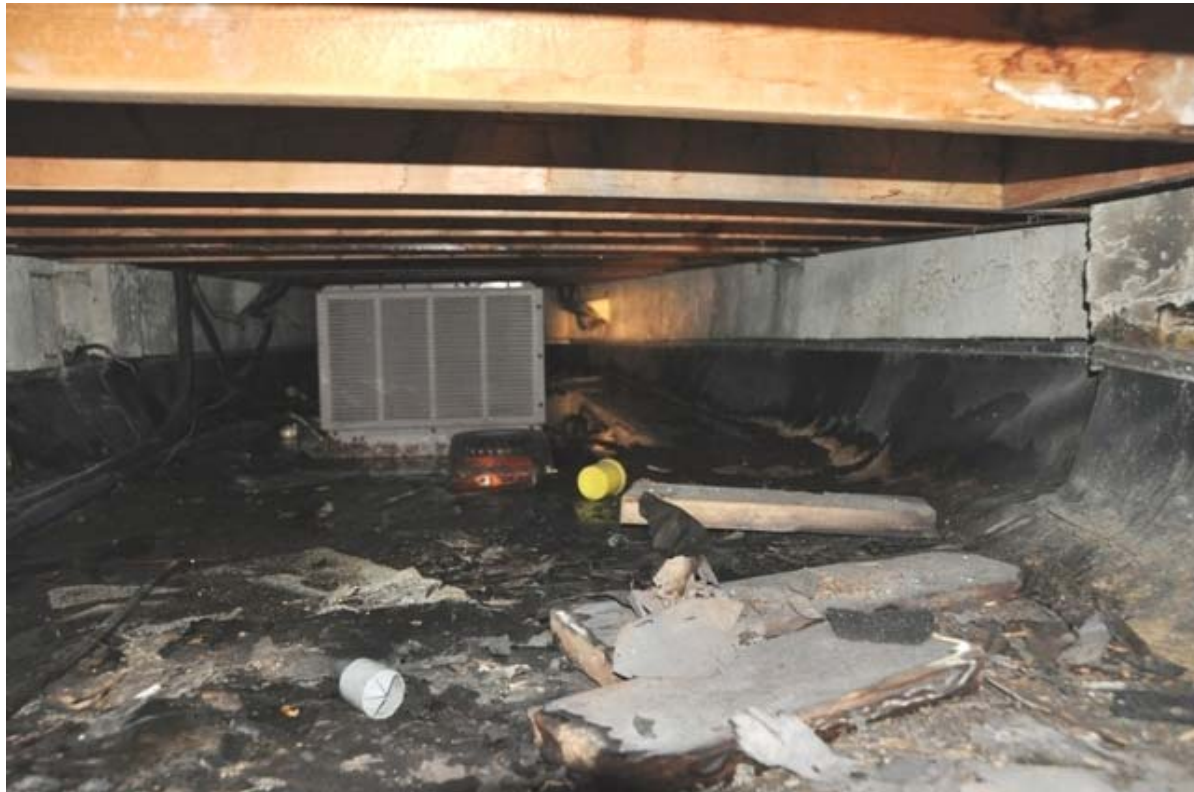
**Membrane roof area on the right side:** Concrete ceiling over third floor hallway is in good condition. No visual cracks, no water stains. Lots of debris under membrane roof structure below A/C platform.

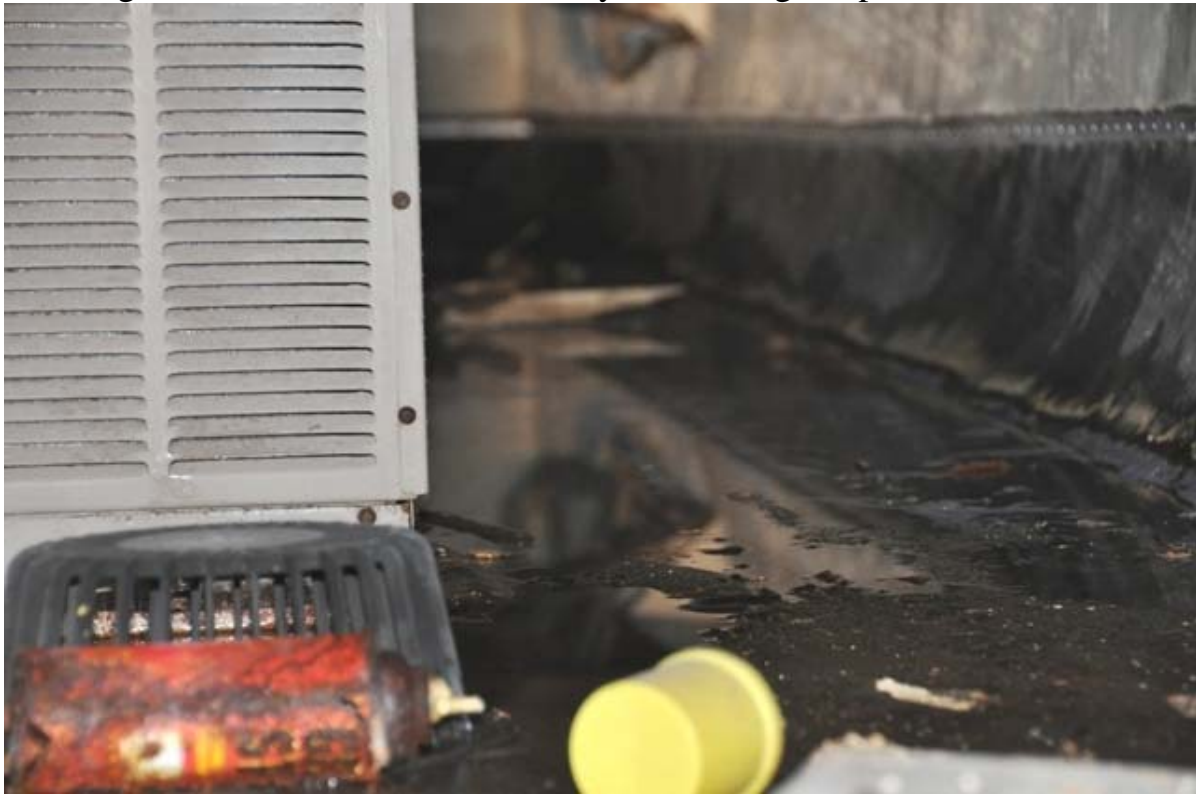
Moisture stains on the roof plywood. Moisture stains on some joists. Bottom parts of some joists are wet and dripping.

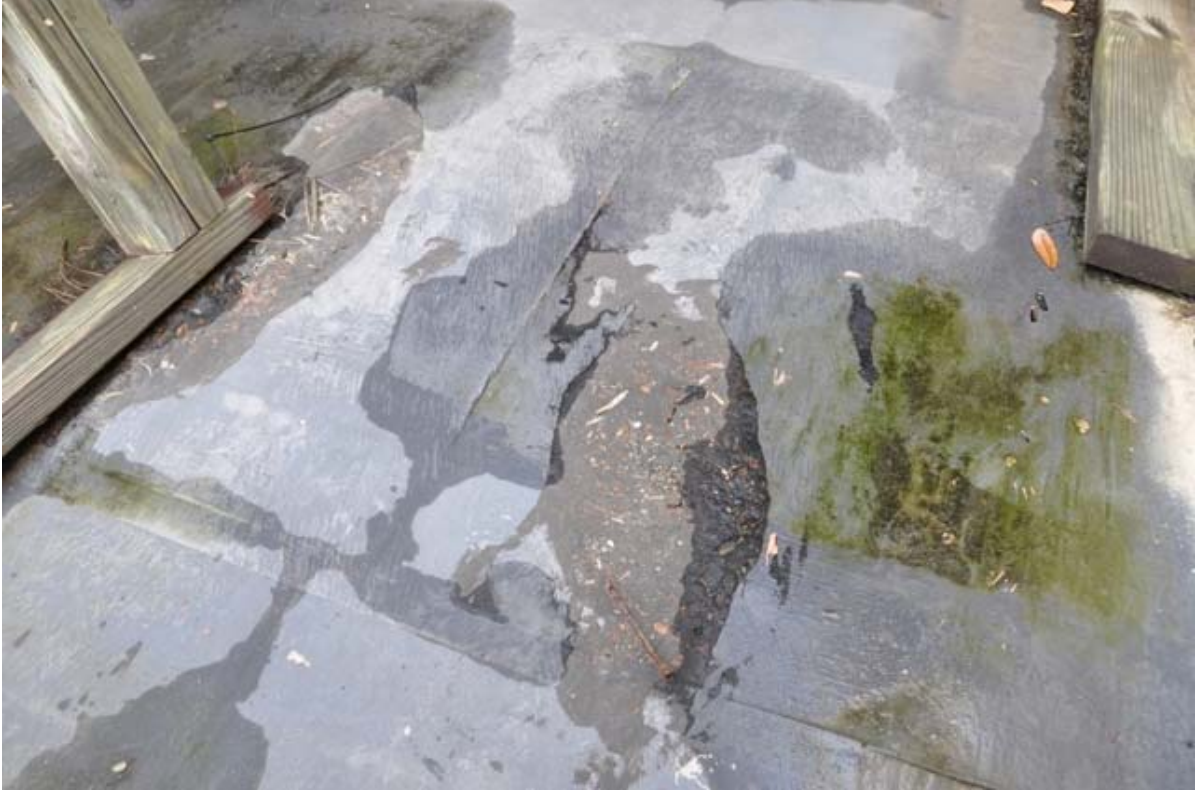
Aluminum ventilation cap under A/C platforms damaged with holes in it. Water penetrating to the space below.

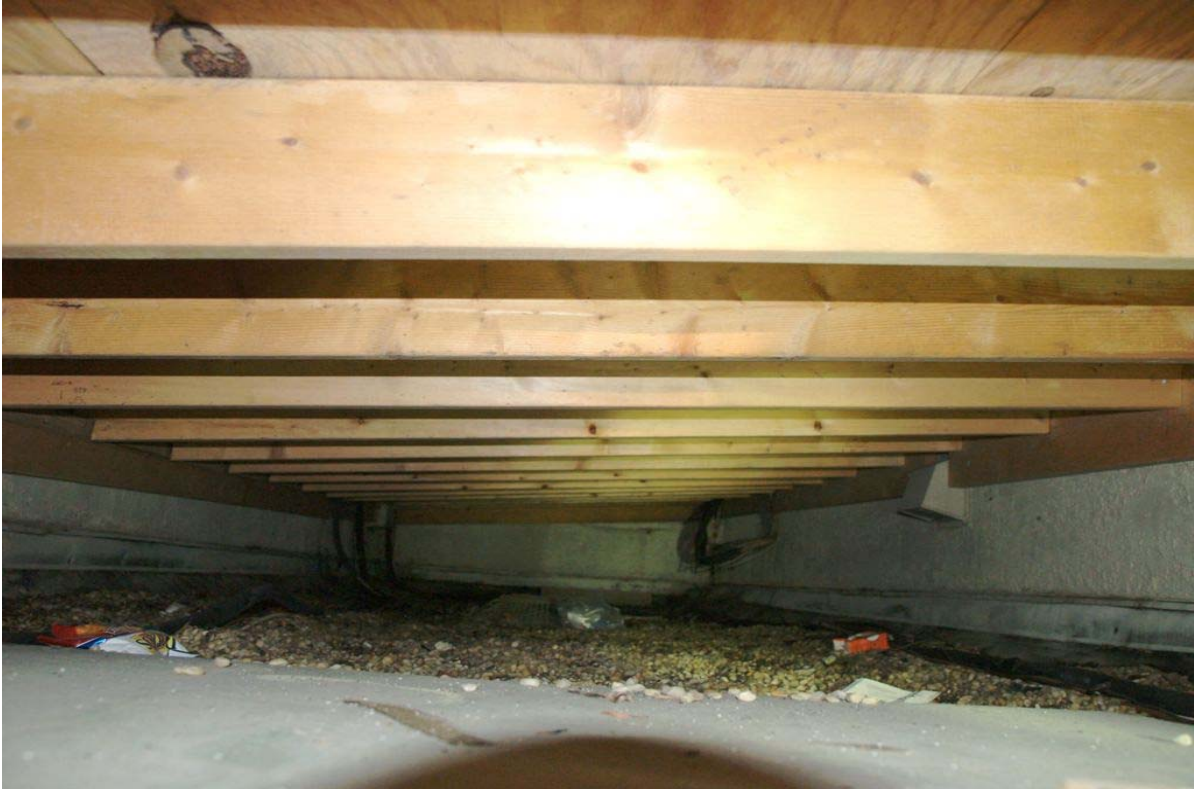
Membrane roof structure across from A/C platforms. No visual moisture damages to the roof structure nor any evidence of water penetration. Gravel fill under membrane roof is dry.

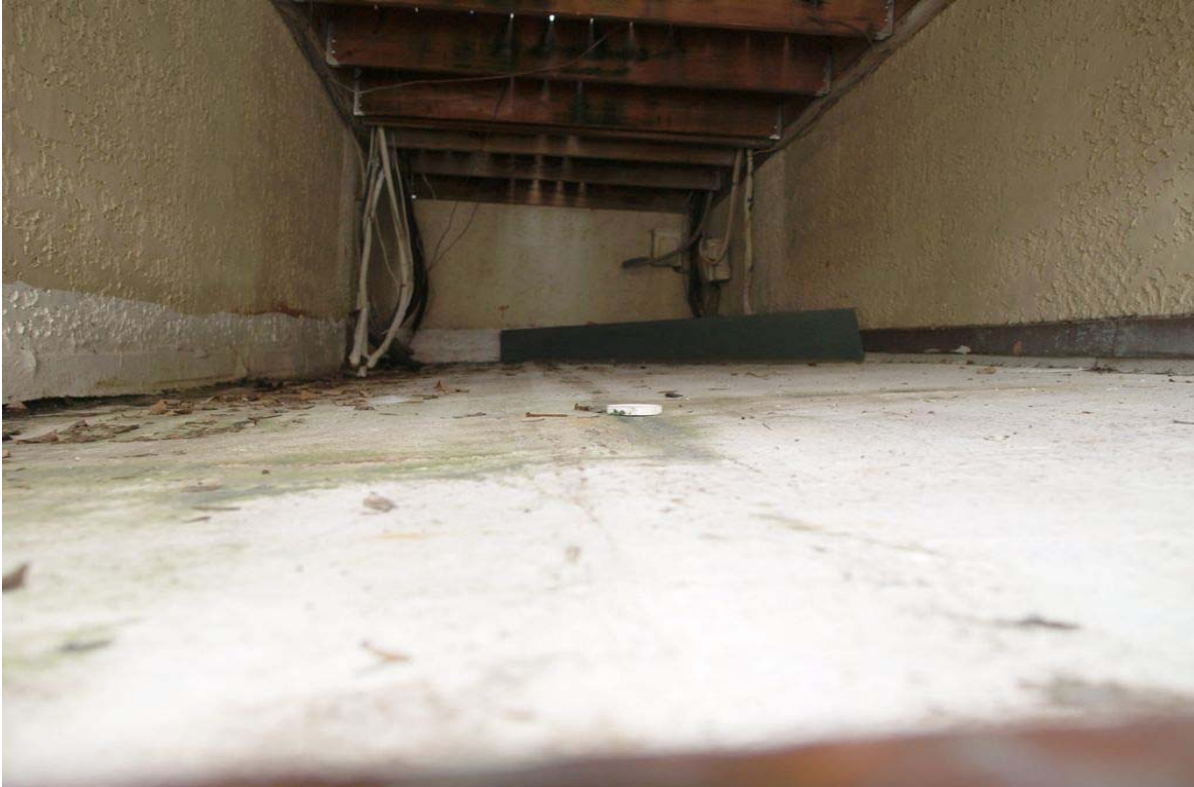
Membrane roofs inspection on building 6 was based on visual observations only. Please feel free to contact our office with any questions regarding this inspection or for further assistance.
