# EURO CONSTRUCTION, INC.

**Re: Assessment of Flat Roof Conditions**  
**Bluff Villas, Regime 56, Buildings 2, 3 & 5**  
**Sea Pines Plantation,**  
**Hilton Head Island, Sc 29928**

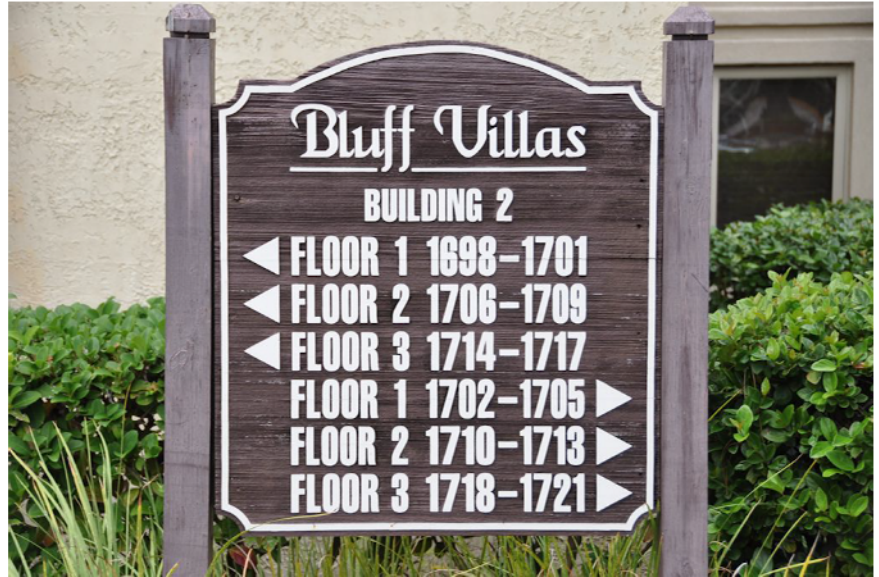
P001

Bluff Villas, Building 2

Flat roof inspection on 11/23/2009  
Immediate repair work necessary in  
the flat roof area on the left side of  
building.

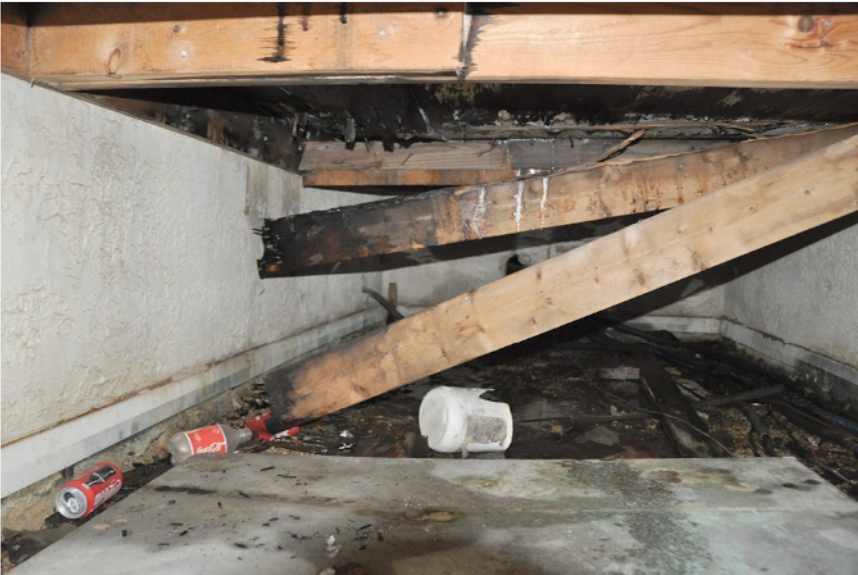
P002

Bluff Villas, Building 2

Severe wood deterioration in the flat  
roof structure by unit 1714.

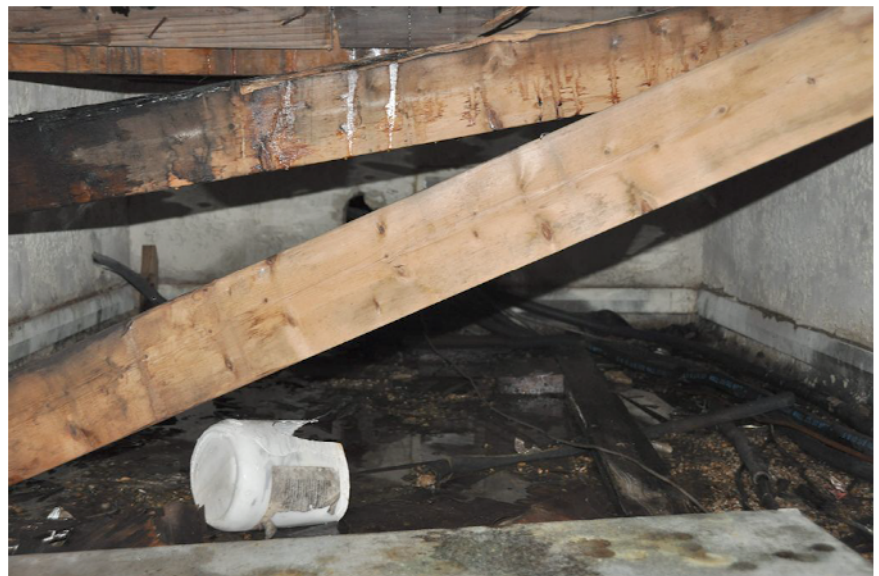
P003

Bluff Villas, Building 2

Flat roof area by unit 1714. lots of  
debris and standing water under  
damaged roof surface.

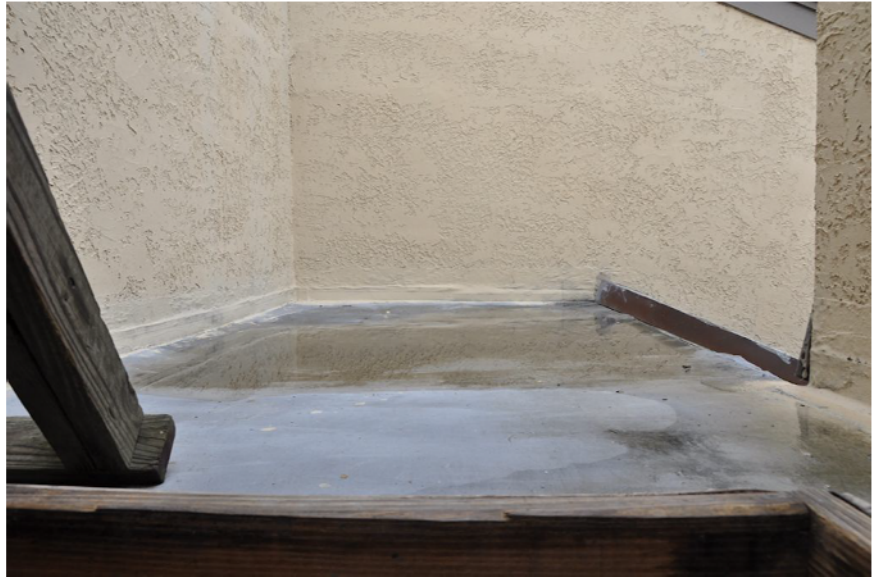
P004

Bluff Villas, Building 2

Sagged roof membrane above damaged structure in pictures 002 & 003. Water is dripping down thru the holes in membrane.

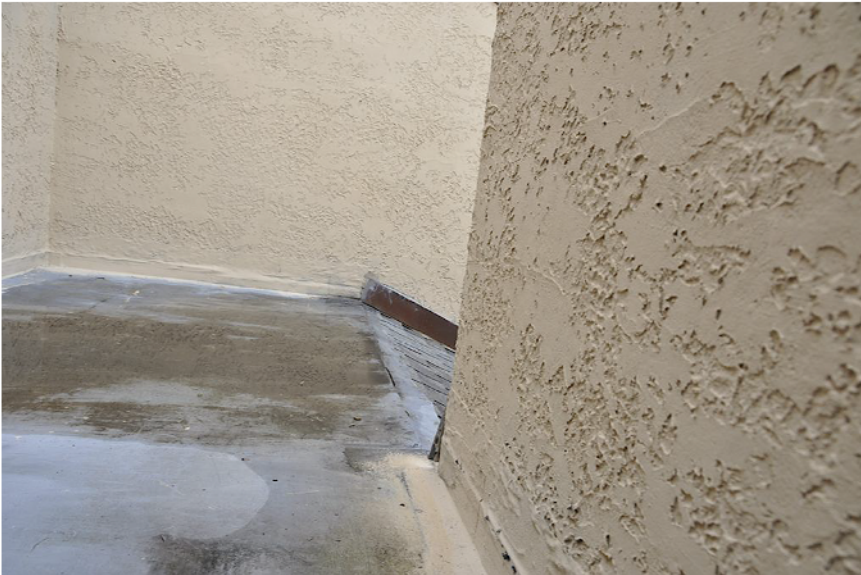
P005

Bluff Villas, Building 2

Broken roof seal at the junction with sloped roof over the stairwell.

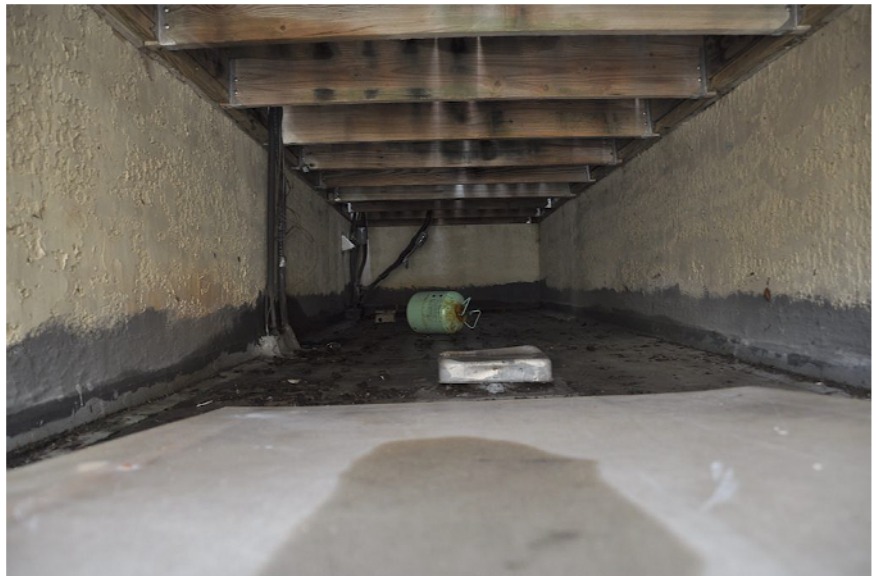
P006

Bluff Villas, Building 2

Flat roof area under A/C platform. No immediate problems observed. Some minor leaks to the framing below noted. No standing water under this section of flat roof. Needs resurfacing.

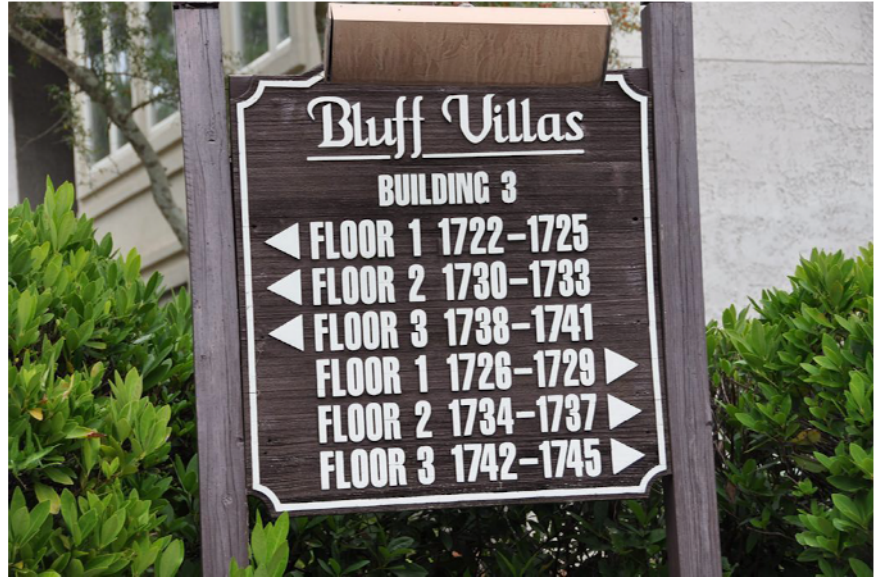
P007

Bluff Villas, Building 3

Flat roof inspection on 11/23/2009  
Immediate repair work necessary in  
the flat roof area on the left side of  
building.

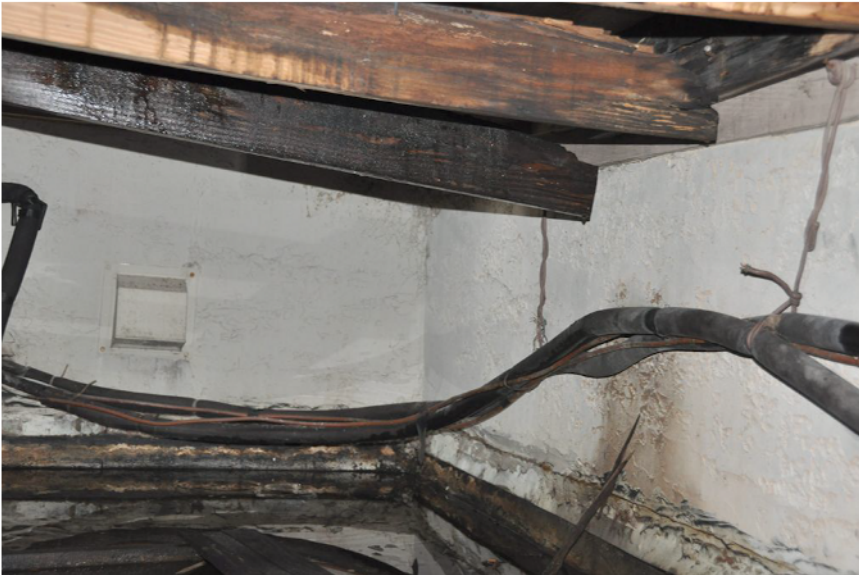
P008

Bluff Villas, Building 3

Flat roof area at the junction with  
sloped roof by unit 1738. Severe  
moisture damages to the roof  
structure. Wood rot in sheathing and  
several joists.

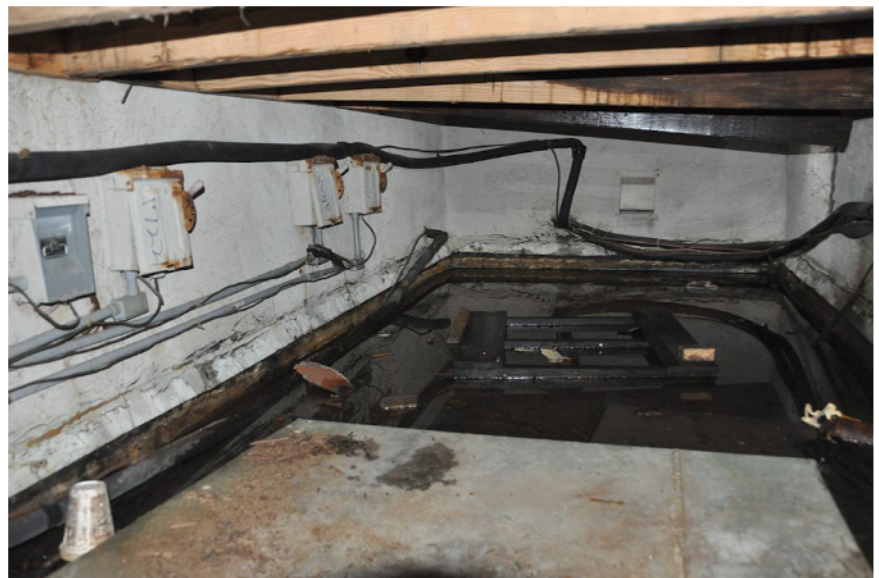
P009

Bluff Villas, Building 3

Large amount of standing water  
under damaged flat roof area.  
Very unusual and inappropriate A/C  
disconnect placement between two  
flat roof structures.

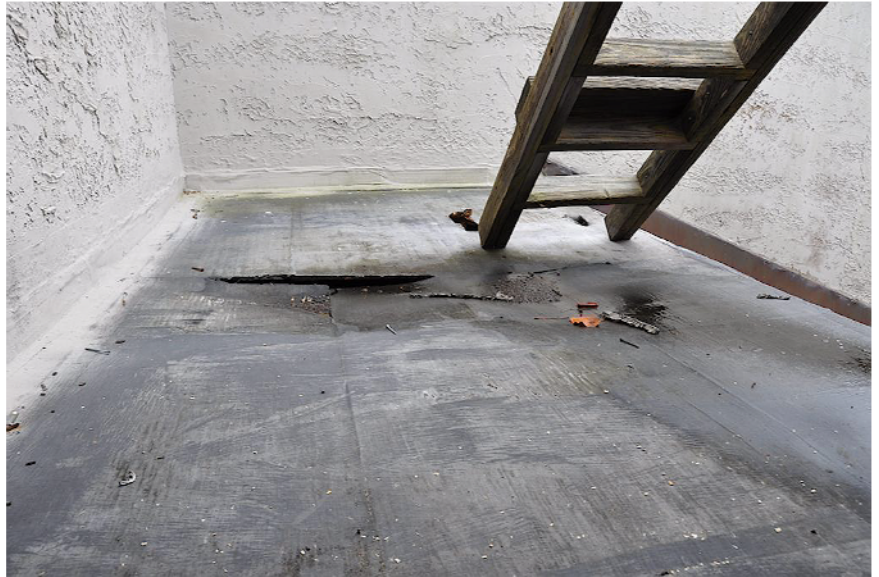
P010

Bluff Villas. Building 3

Three large holes in the roof membrane. Two holes appear to be made with A/C access ladder.

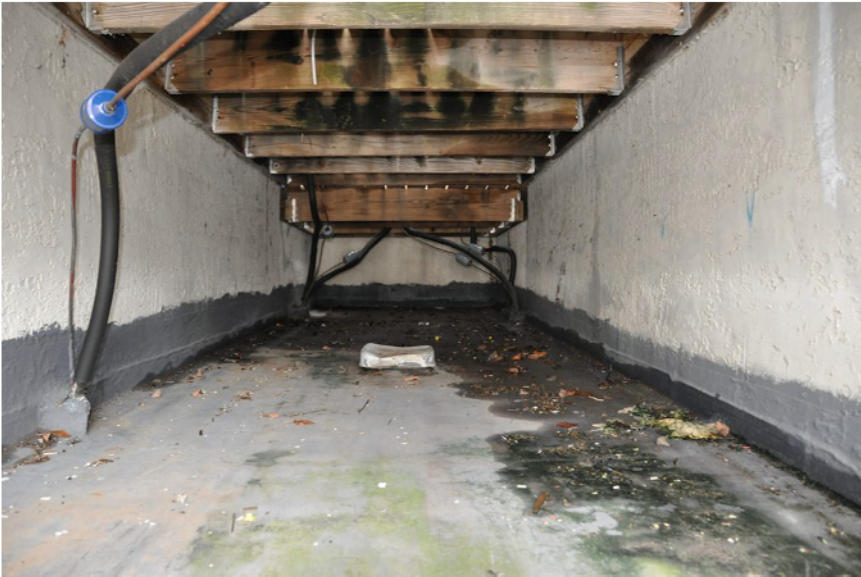
P011

Bluff Villas, Building 3  
Flat roof upper section under A/C  
platform. No visual damages  
observed.

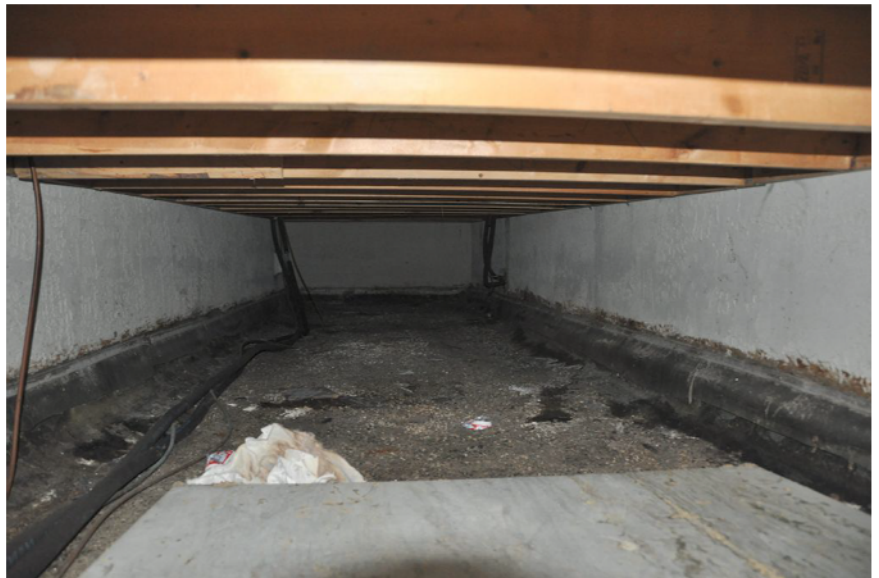
P012

Bluff Villas, Building 3

Flat roof lower section under A/C  
Platforms. No visual damages to the  
framing structure. Few minor leak  
stains noted on the joists.

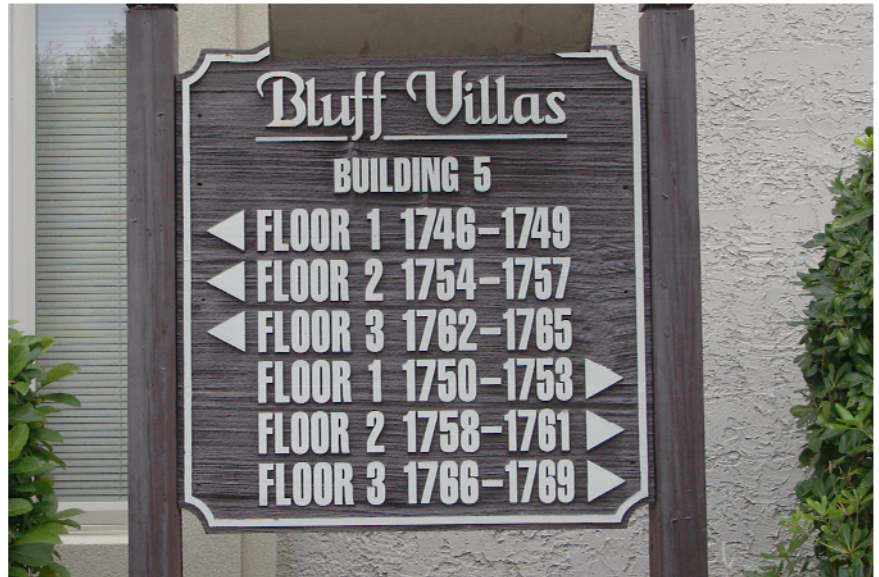
P013  
Bluff Villas, Building 5  
Flat roofs inspection on 11/23/2009

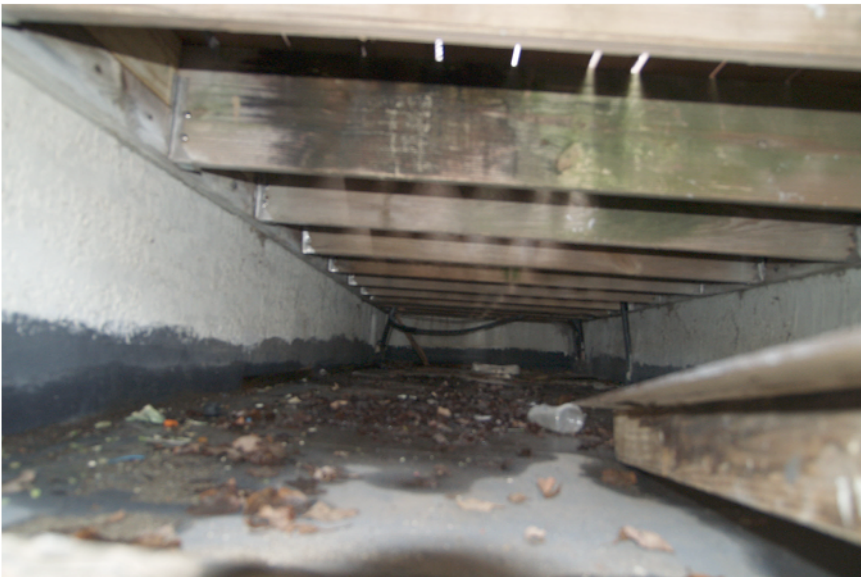
P014  
Bluff Villas, Building 5  
Left side  
Upper flat roof section under A/C  
platform. No visible damages to the  
roof membrane.

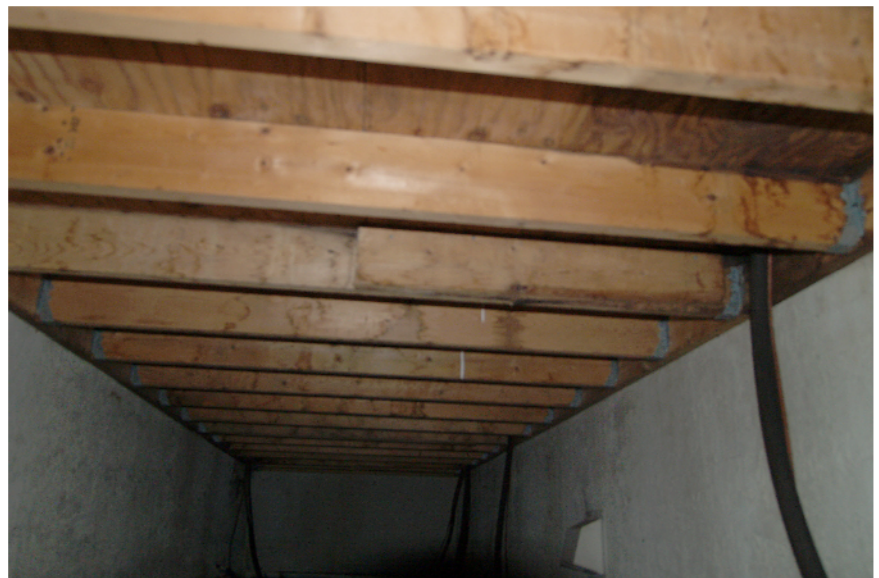
P015  
Bluff Villas, Building 5  
Left Side  
Lower flat roof section under A/C  
platform. Numerous water leak  
stains evident on the joist and  
plywood surface. Membrane above  
needs resurfacing.

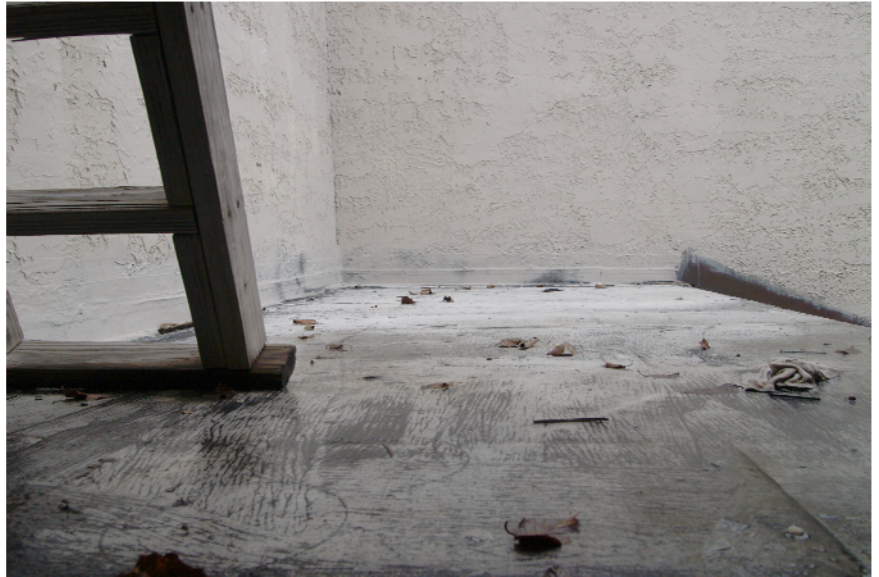
P016

Bluff Villas, Building 5

Left side

Upper flat roof section in front of A/C platform. No visual damages to the roof membrane observed.

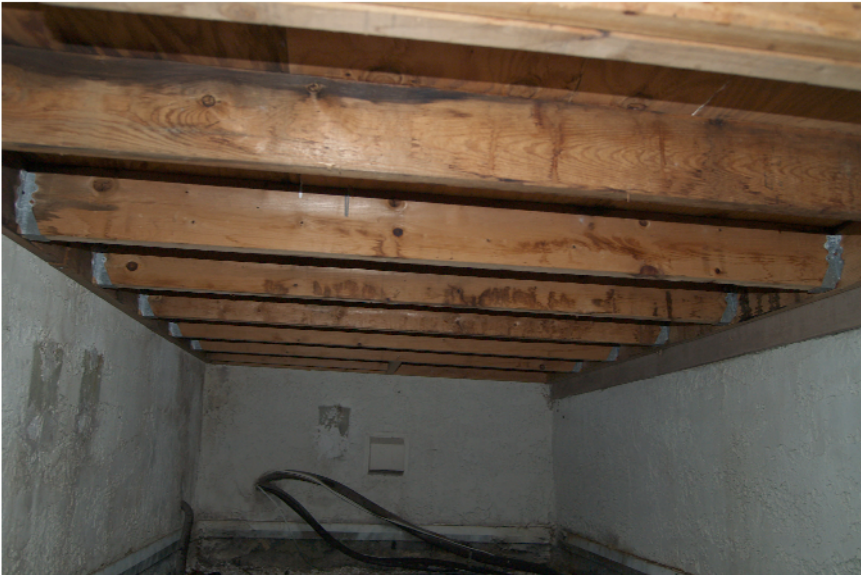
P017

Bluff Villas, Building 5

Left Side

Lower flat roof section in front of A/C platform. Numerous water leak stains evident on the joist and plywood surface. Membrain above needs resurfacing.

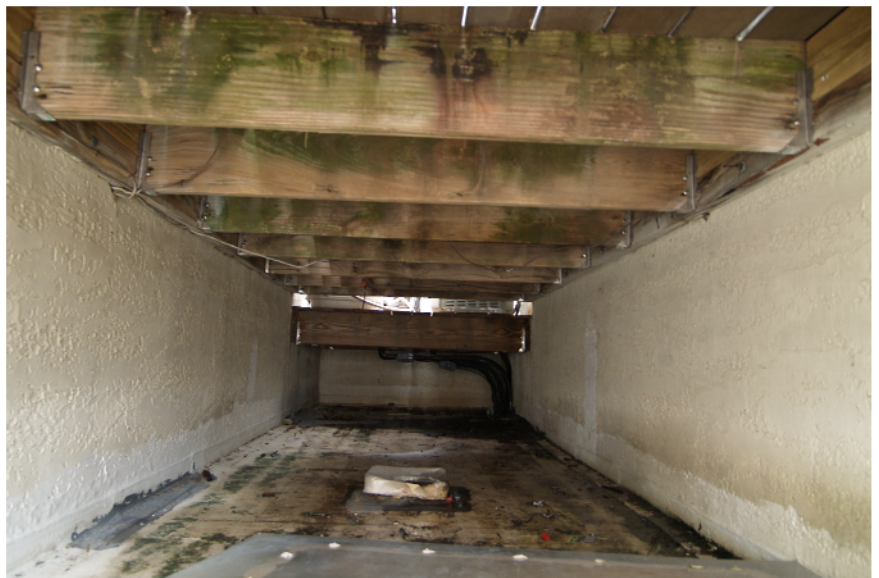
P018

Bluff Villas, Building 5

Right Side

Upper flat roof section under A/c platform. No visible damages to the roof membrane. Standing water around roof vent.

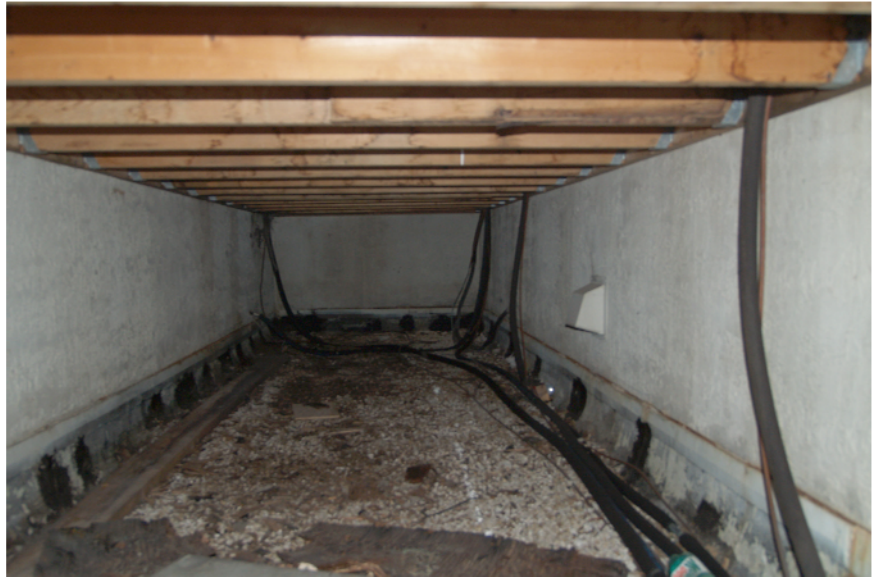
P019  
Bluff Villas, Building 5  
Right Side  
Lower flat roof section under A/C  
platforms. A few minor water leak  
stains evident on joist and plywood  
surface.

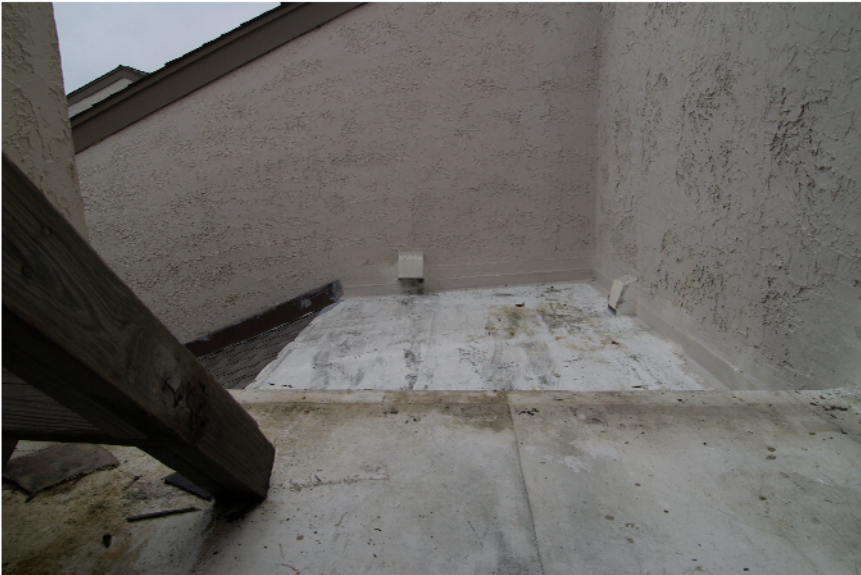
P020  
Bluff Villas, Building 5  
Right Side  
Upper flat roof section in front of A/C  
platform. Roof membrane separation  
evident at the joint.

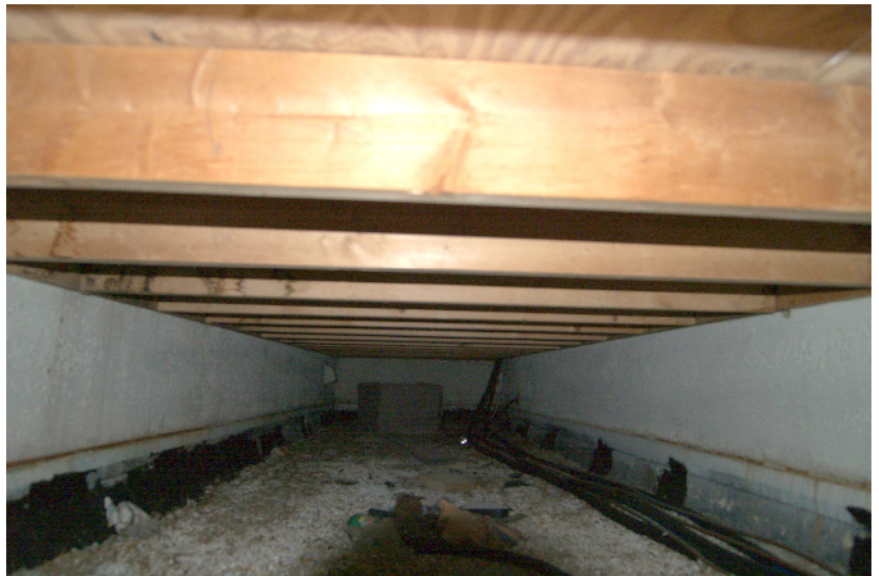
P021  
Bluff Villas, Building 5  
Right Side  
Lower flat roof section in front of A/C  
platforms. A few minor water leak  
stains evident on joist and plywood  
surface.
